U.S. Department  
of Transportation  
**Federal Aviation  
Administration**

## **ADVISORY CIRCULAR**

# **AVIATION MAINTENANCE ALERTS**

**ALERT  
NUMBER  
306**

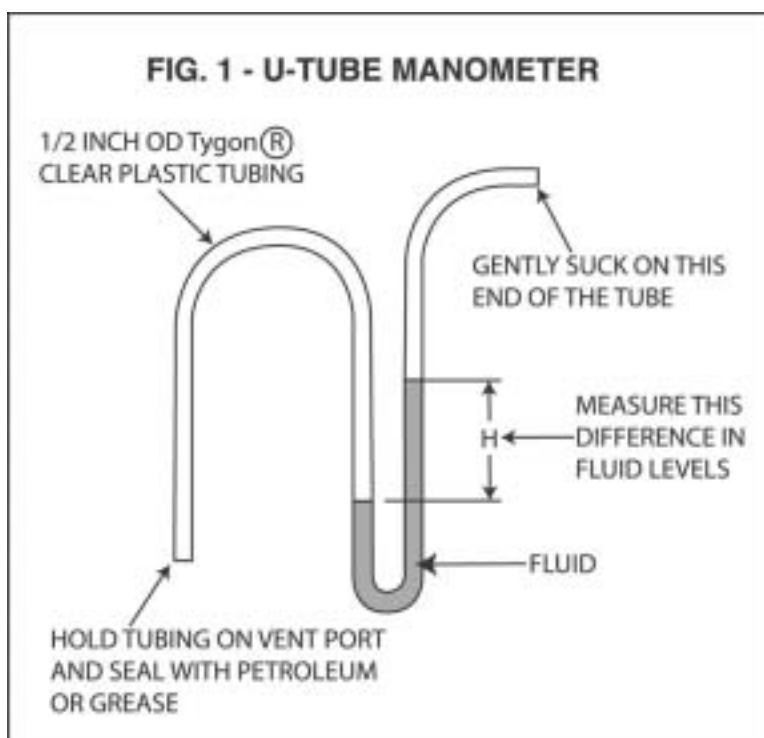
Recently the FAA received a Safety Recommendation on Cessna 120, 140, and 140A model airplanes that had been equipped with replacement fuel caps provided by Monarch Air. Subsequently, Monarch issued a Service Bulletin 120/140-875-2453-001 Rev. A, dated November 2003, that describes a test procedure for their fuel caps to ensure adequate venting of fuel caps. The description below is an excerpt from their Service Bulletin and is recommended being accomplished on an annual basis for all vented fuel caps. However, the venting pressure requirements may be different for other vented fuel cap installations. Recently Monarch Air was reported to have ceased operations and we are providing this to operators who may not have access to their Service Bulletins.

The pass/fail criterion is defined as follows: The cap passes if it allows air into the bulb after applying a small vacuum (0.02 – 0.07 psi) and it fails if it opens immediately or is sealed and does not allow air to pass thru and thus vent the tank. These vacuum pressures correspond to the range of height values,  $h$ , shown in Table 1. Caps that open before the minimum pressure is reached or fail to open before the maximum pressure is reached fail this test. Caps that fail this test are to be replaced before the aircraft is returned to service. This inspection should be performed every 100-hours of flight operation or every twelve months, whichever occurs first, and entered in the aircraft log book.

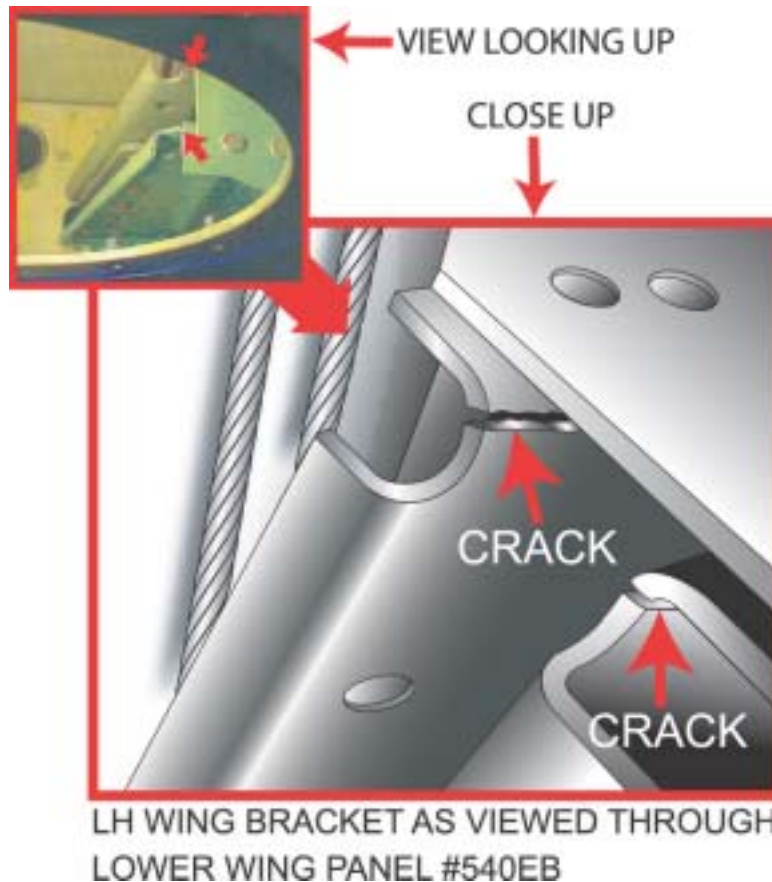
While installing the left wing aileron cables, the technician discovered the left flap actuator upper support bracket (P/N 2325079-13) and lower support brackets (P/N 2325079-15) were cracked.

Part total time: 4,102 hours.

The submitter recommended removing the panel 540EB on the left wing and 640EB on right wing to inspect the brackets during every 1,200-hour inspection.

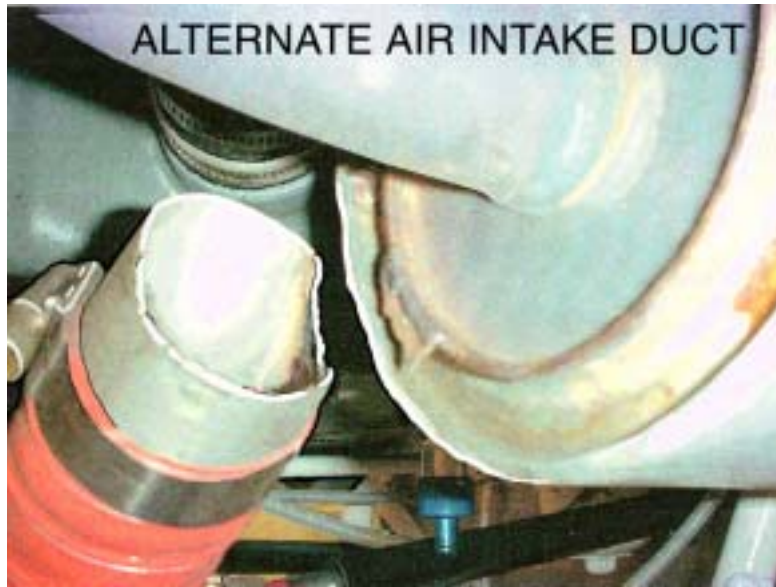
During an annual inspection, the technician discovered the alternate air intake duct (P/N Q-2-6) was broken off the left exhaust muffler at the weld. The duct and hose were chafing against the engine mount tubular structure. (Refer to the illustration.)

The submitter believes the failure was due to an inadequate means of support for the alternate duct and hose.

Part total time: 100 hours.
